MANDATORY SERVICE BULLETIN

ARTOUSTE III**No. A218 73 0803**

Subject: Equipment/accessory. Check for cracks on lower union of flexible fuel pipe between electric fuel cock and start valve.

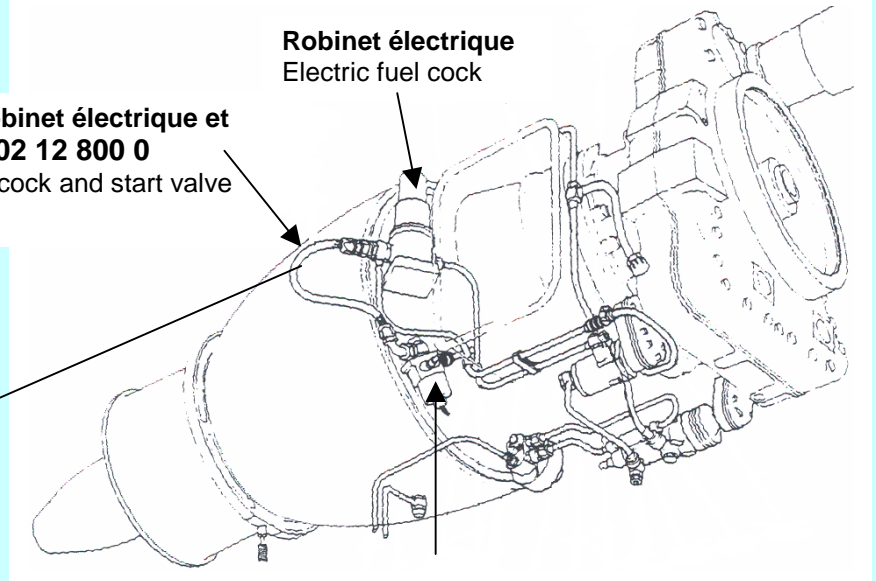
Tuyauterie carburant entre robinet électrique et clapet de démarrage Réf. 0 202 12 800 0
Fuel pipe between electric fuel cock and start valve
P/N 0 202 12 800 0

Robinet électrique
Electric fuel cock

Clapet de démarrage
Start valve

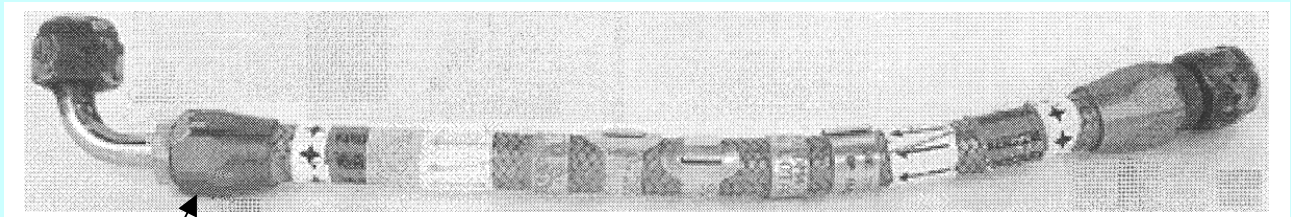
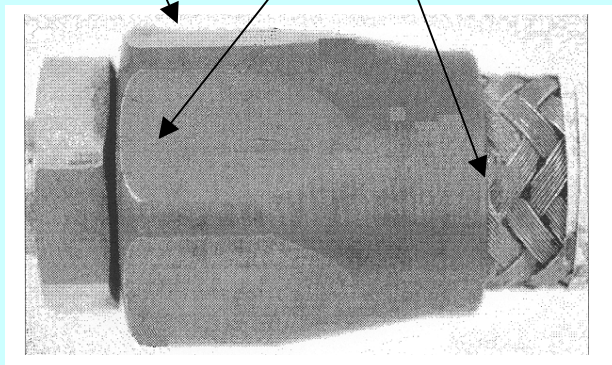
3 occurrences of cracks have been detected on the unions of fuel pipes P/N 0 202 12 800 0 caused by exfoliating corrosion.

The vertical position of the union facilitates retention of various products (washing fluids, salt water, etc.) which may initiate corrosion.

Raccord à contrôler
Union to be checked

Position des criques
Location of cracks

(b) Using magnifying glass (minimum: x6), perform visual check for cracks on lower union (pipe start valve side).

(c) If cracks are found, replace pipe: refer to the Maintenance Manual.
