Alouette

N° 05.62

SUBJECT : TIME LIMITS

Checking the tail gearbox strut P/N 3160S.23.10.220

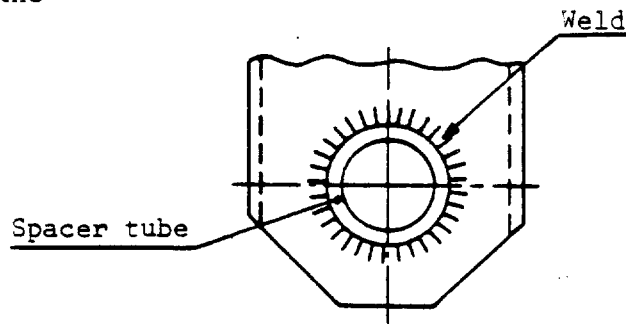
Checking the spacer weld beads on strut for defects.

Remove the strut (refer to chapter 53-3 of Maintenance Manual) and submit the spacer tube weld beads at the lower section to a dye penetrant or a radiographic inspection.

All defects identified as incomplete fusion will result in scrapping the strut.
