**H***Alouette*313  
316  
318  
319

N° 05.69

**SUBJECT : TIME LIMITS**

Inspection of forward transmission deck attachments.

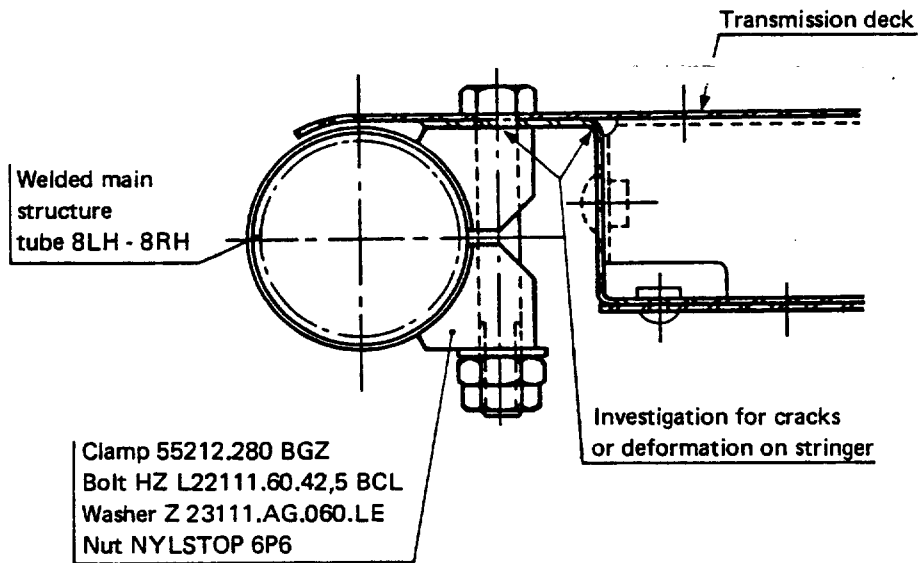
SHEET 1

In order to avoid that the development of fatigue cracks at the forward attachment clamps P/No 55212.280 BGZ of the 'Z' stringer of transmission deck leads to sagging of the transmission deck in the fixing area of the flying control relay lever support, embodiment of the following measures is now mandatory :

- (a) visually check that there are no cracks or deformation on the lower side of the stringer.
- (b) Make sure that there are no cracks in the inner bending radius of the stringer, by carrying out a die penetrant inspection.

**FORWARD TRANSMISSION DECK ATTACHMENTS**

- replace the 'Z' stringer by a stringer with the same P/No
- or
- replace the transmission deck.

- Replace the 'Z' stringer by a stringer with the same P/No
- or
- Replace the transmission deck.
