H*Alouette*313
316
318
319

N° 05.74

SUBJECT : INSPECTION INTERVALS

Landing gear inspection

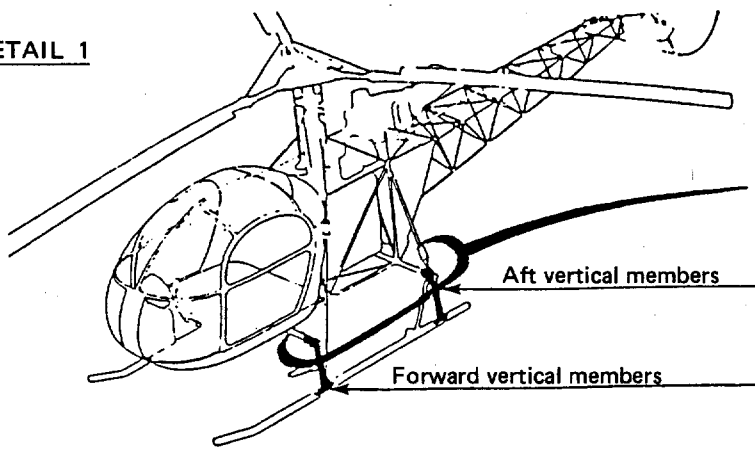
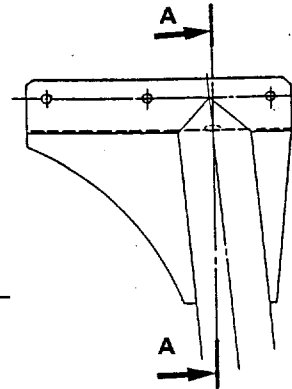
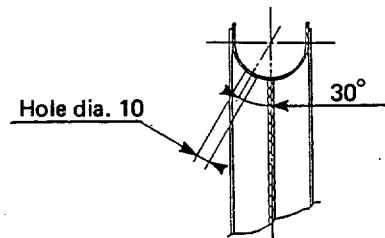
DETAIL 1

Cracks and / or internal corrosion have been observed on certain Alouette II and III landing gear units. This Service-Bulletin specifies periodic inspection of the landing gear units to ensure early detection of cracks and / or corrosion to permit repair.

Check visually for cracks, especially in weld zones.

- . Drill part as per Figure 1 Detail 1 (for Alouette II) or Detail 2 (for Alouette III).

- . Blank off the 10 mm dia. hole using plug P/N 3130.76.12.002 bonded with EC 1236 adhesive as per Standard Practices Manual card 20.06.01.404
 - . Seal with PR 1422G compound as per Standard Practices Manual card 20.05.01.205.
 - . Reinstall part.
- (b) If part has been repaired as per para. 1C (1) (b) in an unauthorized shop
- Return the part to the manufacturer or to an authorized repair station for X-ray examination of weld seams and corrosion inhibiting treatment if no cracks are found, in accordance with paragraph 1C (2).
- (c) If part has been repaired as per para. 1C (1) (b) by the manufacturer or in an authorized repair station
- Apply corrosion inhibiting treatment as per paragraph 1C (2) (ac).
 - Reinstall part.

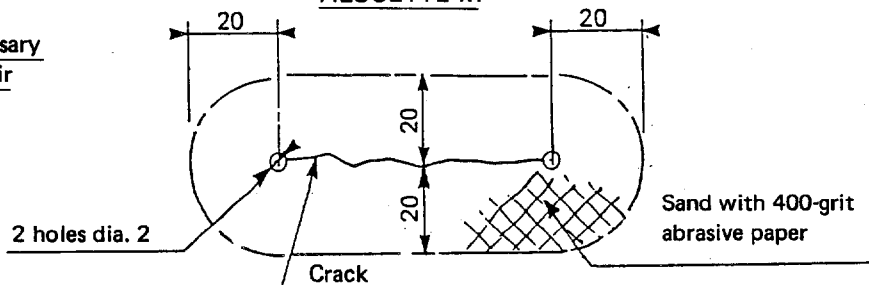
DETAIL 3
FIGURE 1

Repair if necessary
(only one repair
authorized)

- . Strip the crack zone as per Standard Practices Manual card 20.04.02.401 paragraph 1.4.
- . Grind the weld seam if it is cracked.
- . Using 400-grit abrasive paper, sand off the metal spray protective treatment over an area at least 2 cm wide around the crack, and stop-drill each end of the crack with a 2 mm dia. hole (Figure 1 Detail 3).
- . Weld as per Standard Practices Manual card 20.02.05.402 paragraphs 1.3 and 1.4.
- . Carry out a dye penetrant examination of the new weld seam as per Standard Practices Manual card 20.02.09.101.

THE REPAIR OPERATION DEFINED IN PARAGRAPH 1C (1) (b) SHALL NOT BE CARRIED OUT MORE THAN ONCE.
