**H***Alouette*313  
316  
318  
319

N° 05.78

**SUBJECT :** TIME LIMITS

Monitoring the Blade Spacing System Cable-to-MRH Attachments.

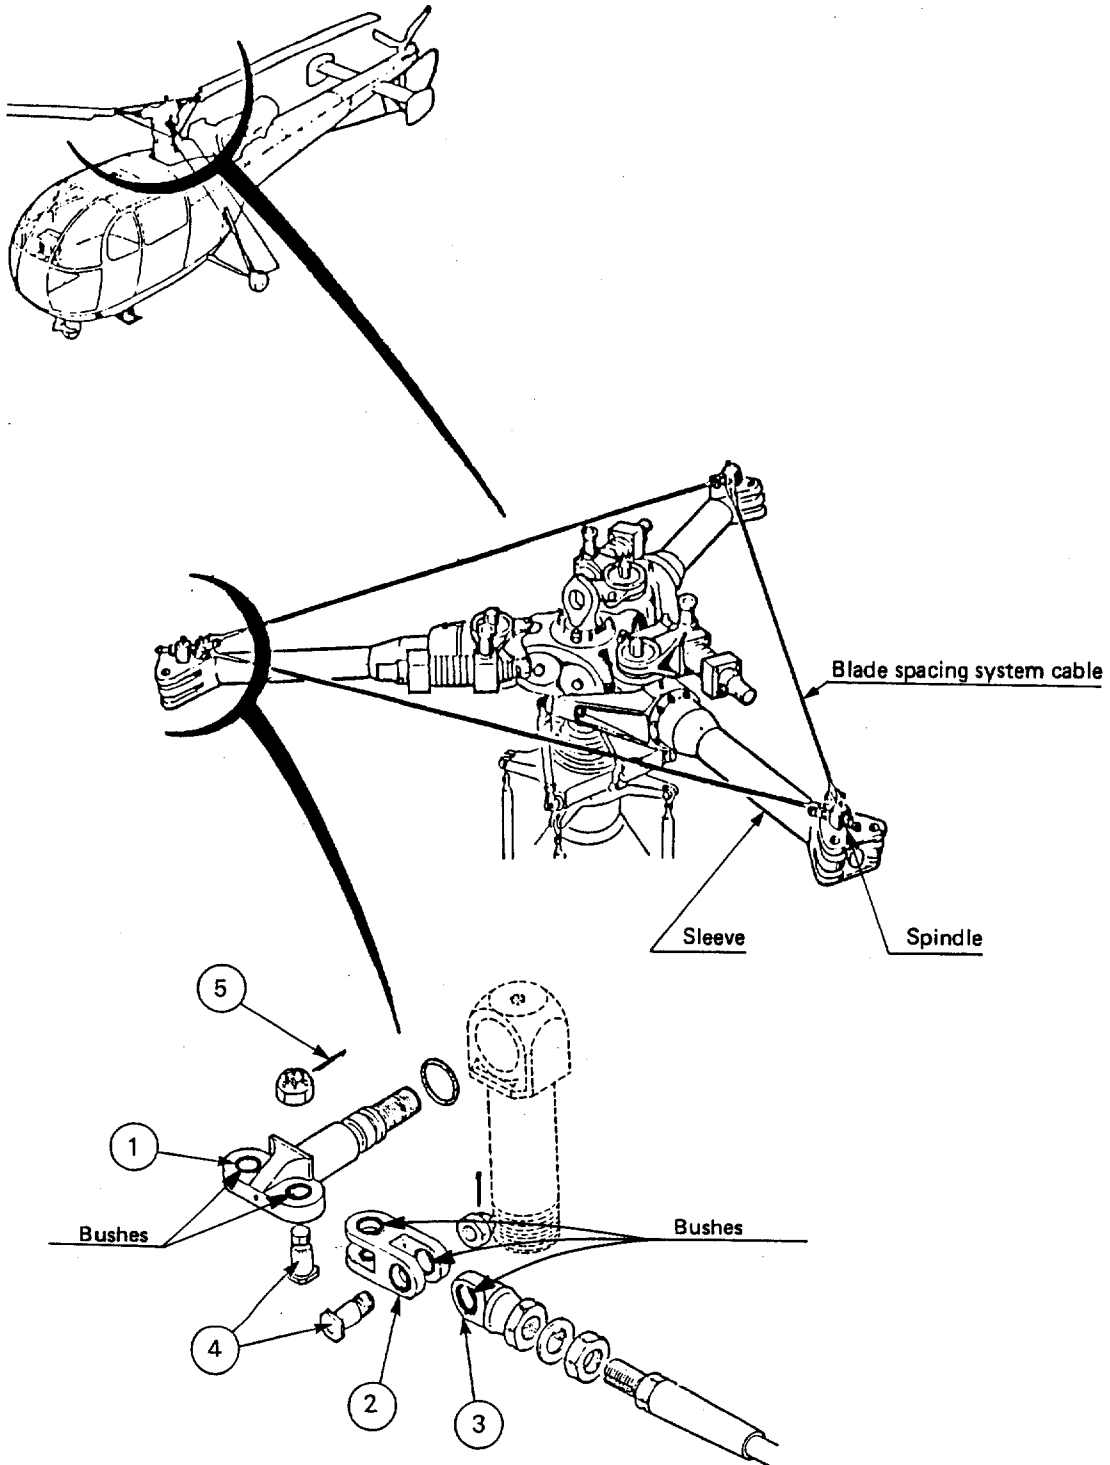
FIGURE 1

The following measures must be applied in order to detect any wear on the blade spacing system cable-to-MRH attachment assembly bushes :

- Visually check that spindle bushes item 1, shackle bushes item 2 and cable end-fitting bushes item 3 are not broken.

- If no bushes are broken :  
Return the aircraft to flight configuration.
- If one or more bushes are broken :  
Replace the incriminated spindle, shackle or cable with new parts.

*After fitting bolts item 4 as per MET Work Card No. 57.00.302, page 2, check that they rotate freely. If they stick, discard and replace the incriminated bolts with new bolts.*

- In all cases, discard and replace cotter pins item 5.
