aerospatiale

316
319
Alouette

No. 05.80

Monitoring the Yaw Control Pedal Unit Support
P/N : 3160S-86-12-300 or 3160S-73-86-380.

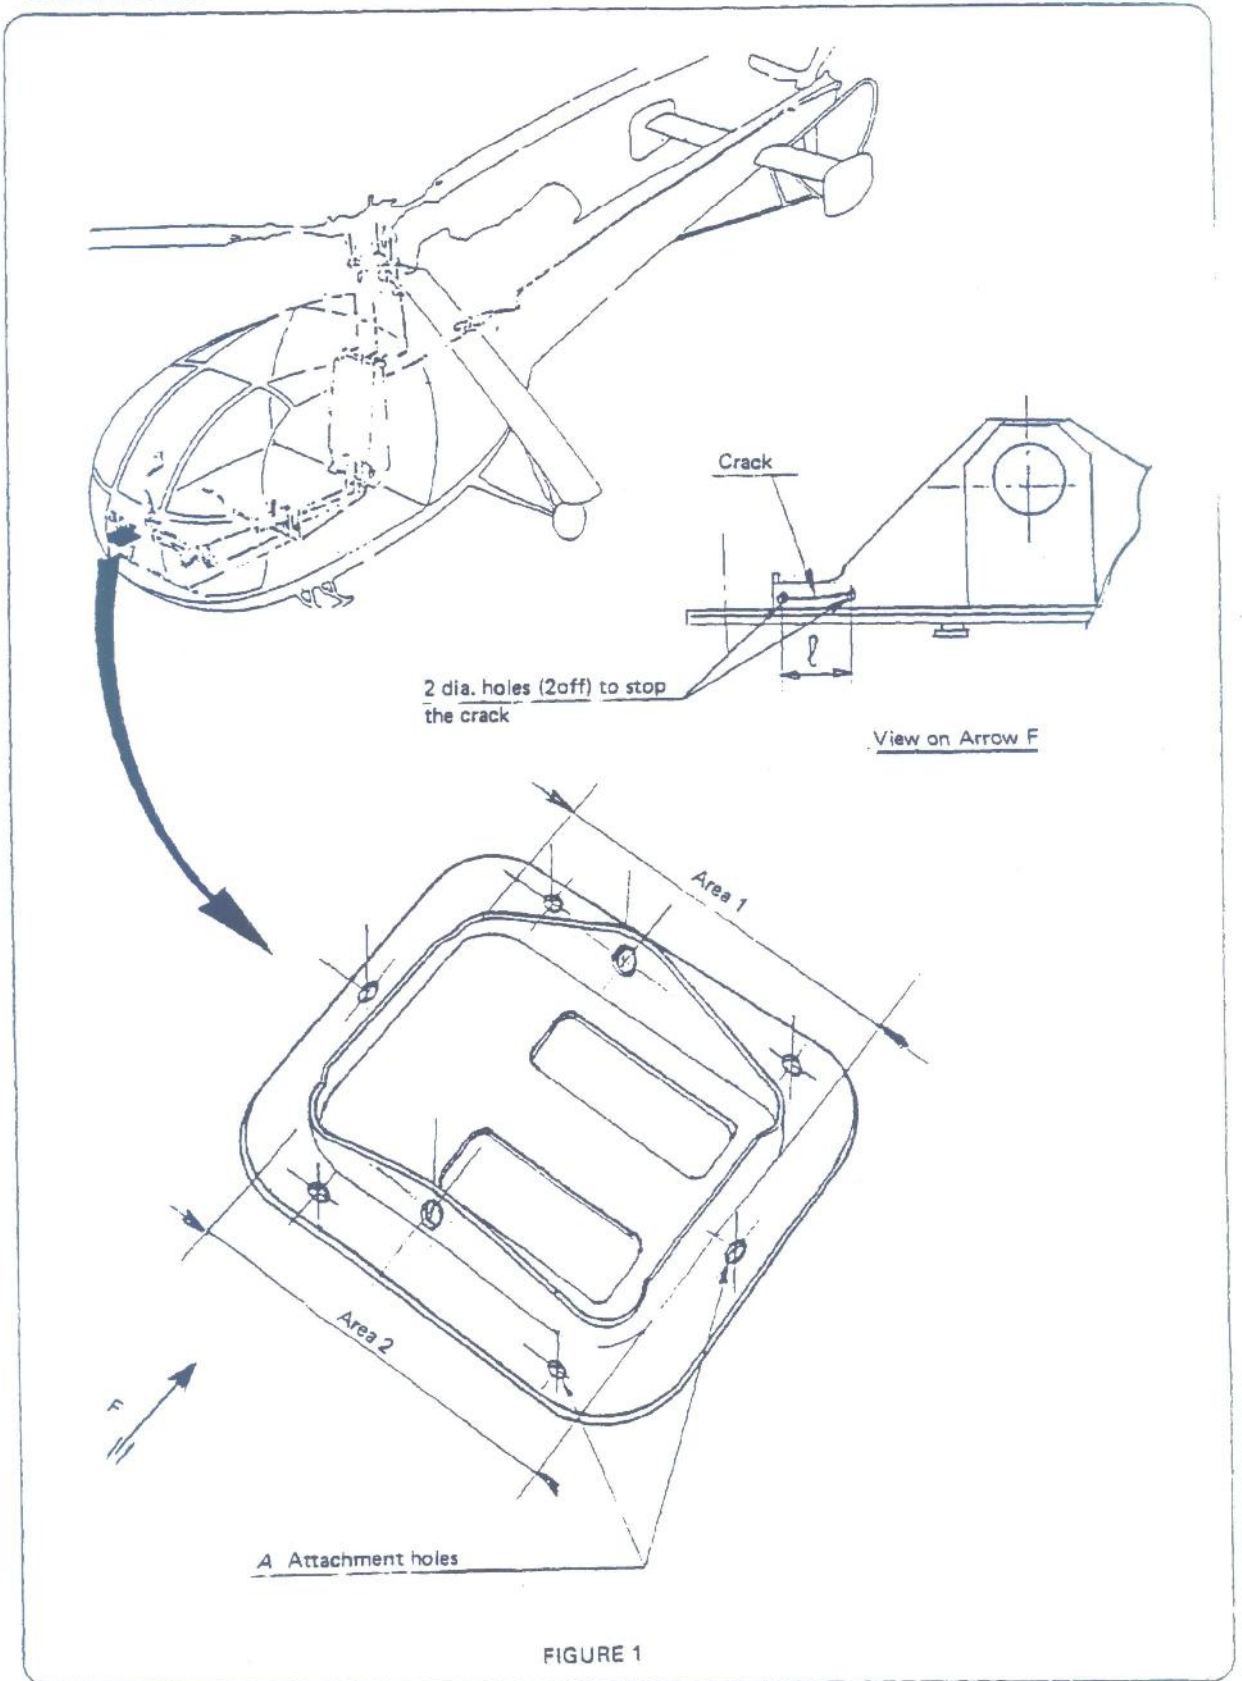
Ensuring the support is free from cracks.

Subsequent to the discovery of cracks in the yaw control pedal unit support, the following measures must be taken :

- (b) Perform a dye penetrant crack detection inspection (as per Standard Practices Manual Work Card 20.02.01.01) in areas 1 and 2 on the bend radii and flanged edges.

- (a) If no cracks are found, reinstall the support
(b) If a crack is found, measure its length "l" :

(ba) - If "l" is equal to or less than 60 mm :

. Drill a 2 mm dia. hole at each end of the crack and reinstall the assembly,
then :

. Every 100 flying hours, remove the support to check for any development of the crack.

IMPORTANT : Replace the support during the next type T inspection

(bb) - If "l" is greater than 60 mm, replace the support within 50 flying hours
