# SERVICE BULLETIN

## MANDATORY No. 05.84

**SUBJECT:** TIME LIMITS  
Monitoring of Horizontal Stabilizer Spar Tubes.

Alouette III helicopter versions : 316 B, 3160, 316 C, 319 A and 319 B.

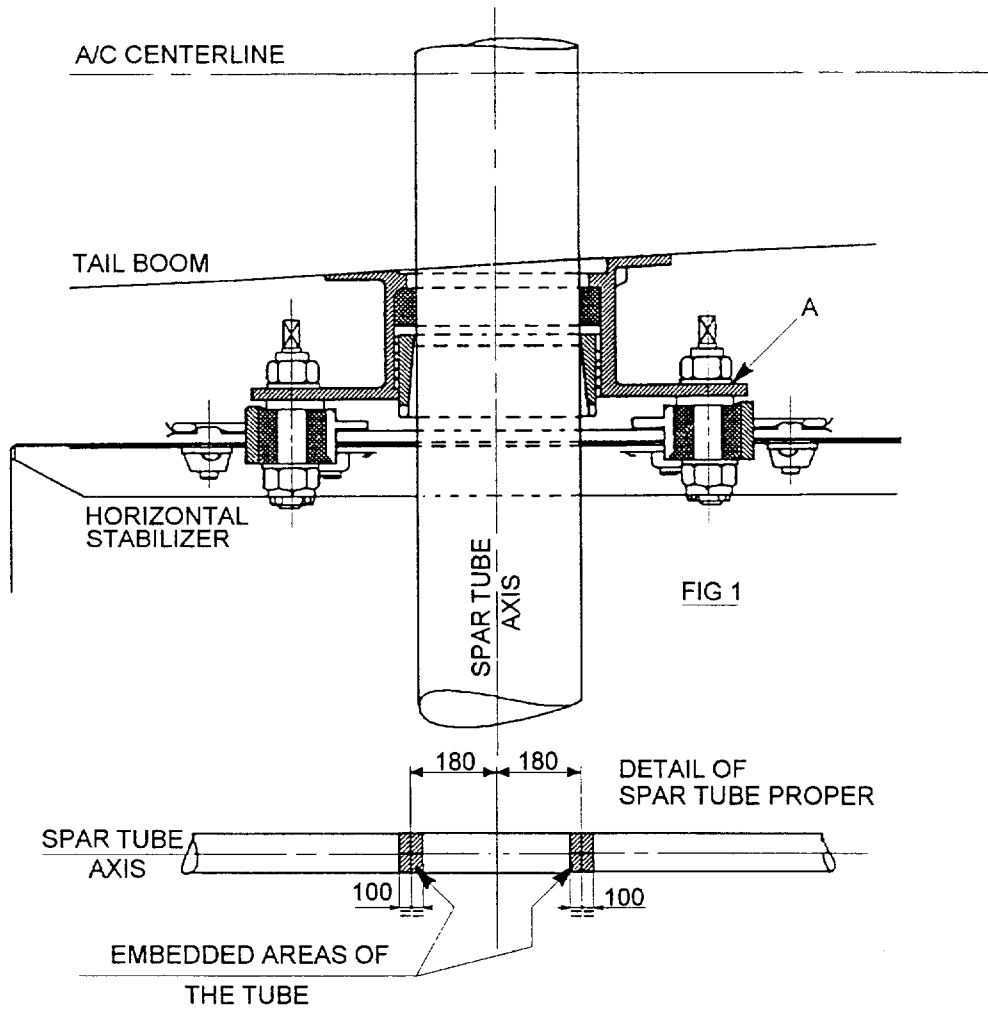
Using a tenfold magnifying glass (see photograph on page 5), identify the defects as follows :

Diameter : In order to cause the tube to be discarded, the diameter of pittings should be greater than or equal to 0.5 mm (i.e. 0.05 mm actual diameter).

Aspect of corrosion pittings seen with an approximately tenfold magnifying glass.

- Strip off the tube of its paint as per MTC.
- Perform a dye penetrant inspection on the tube as per MTC in order to detect any possible fatigue cracks.

b) If there are some cracks : scrap the tube.

c) If there are no cracks : do the applicable touch-ups to correct the defects (corrosion, fretting) in the following manner :

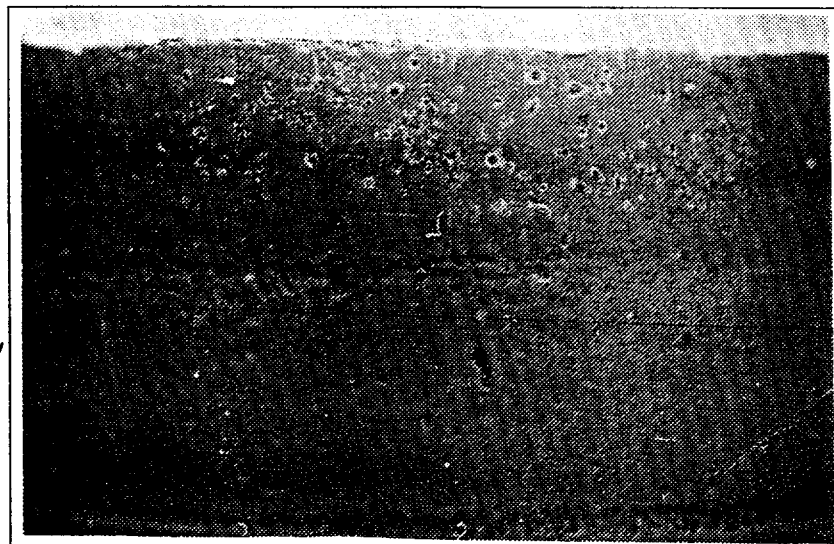
FIGURE 1

3) Areas to be checked (Figure 1)

The whole tube and in particular the embedded portions on either side of left-hand and right-hand fittings (A), and on the periphery of the tube (Figure 1 - DETAIL).
