EUROCOPTER FRANCE

**SERVICE BULLETIN
ALOUETTE**

No. 05.86

Monitoring the tab area of main blades with reinforced trailing edge ledge.

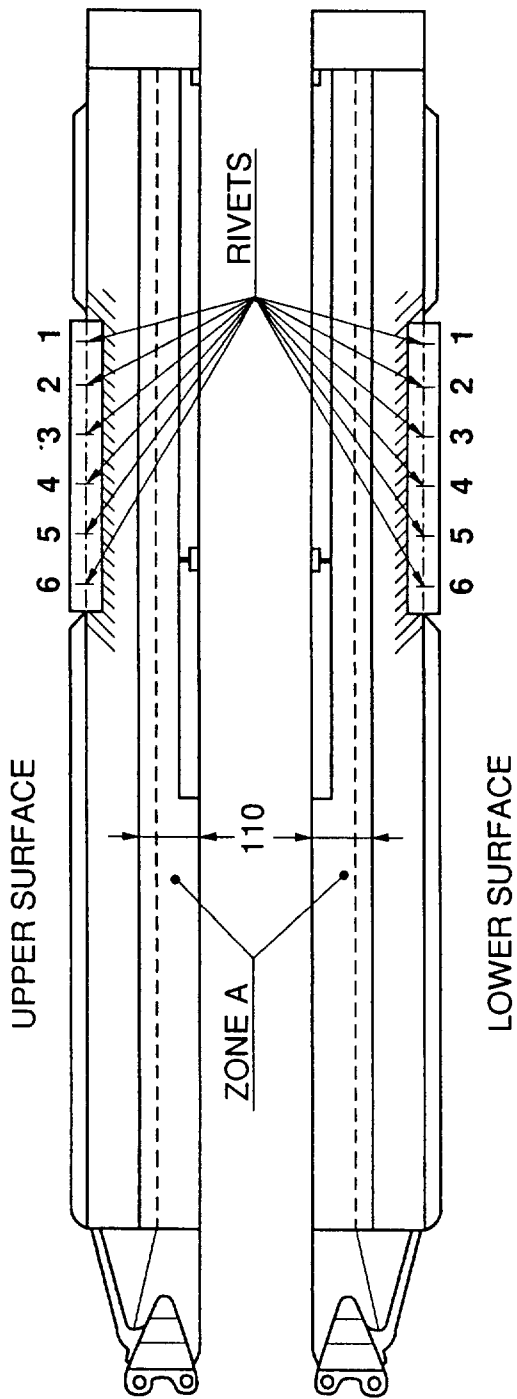
FIG. 8

REFERENCED CARDS	INSPECTION	<u>MAIN BLADES</u> Inspections - Checks	<u>ALOUETTE III - LAMA</u> 57-10-601-8
57-10-806		<ul style="list-style-type: none"> - That the score, if it is perpendicular to the blade centreline, does not exceed 50 mm in length. - That the repair is carried out in accordance with the referenced Card. - That the material removed during repair does not exceed 0.2 mm in depth. <p><u>NOTE:</u> Return the blade to the manufacturer or an approved workshop if any perforation is found.</p> <ul style="list-style-type: none"> - After touching up with paint, delimit the repaired area with a red paint line when returning to service. - Pay particular attention to these areas during each check. - If cracks appear, remove the blade. - Return the blade to the manufacturer. 	
57-10401		<p>(4) <u>Crack detection</u> (Figure 8)</p> <p>(a) All blade types:</p> <p>Check the skin for cracks, in particular at the trailing edge and root strip.</p> <p><u>NOTE:</u> If a crack perpendicular to the blade centreline cuts the skin entirely and ends at less than 1 cm from the spar root, scrap the blade definitively.</p> <p>(b) Blade types: 3160S-11-30-000 / 40-000 / 50-000</p> <p>Check for cracks on the upper and lower surface skins along the edge of the tabs, and in particular, forward of each rivet.</p> <ul style="list-style-type: none"> - If a crack is found in this area and does not reach zone A, return the blade to the factory for reconstruction. - If a crack reaches zone A, scrap the blade on-site.

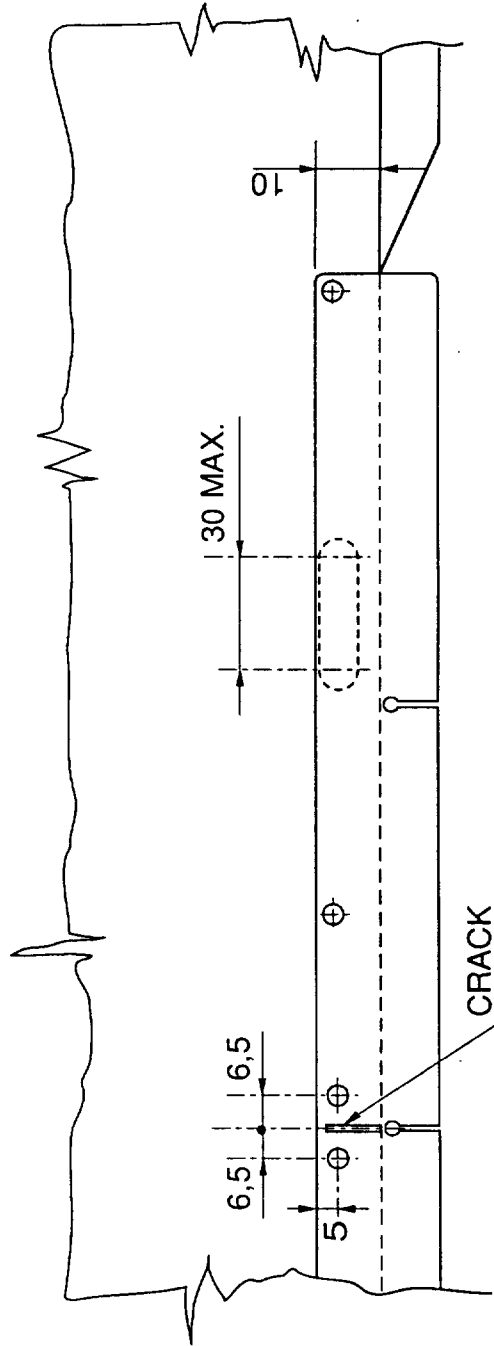
FIG. 9

REFERENCED CARDS	INSPECTION	<u>MAIN BLADES</u> Inspections - Checks	ALOUETTE III - LAMA 57-10-601-9M
57-10-810		<p>1. <u>DEFECTS ON TABS</u></p> <p>Effective for blades: 3160S 11 30 000 / 40 000 / 50 000</p> <p>(1) <u>Separation</u>: Open or closed separation is acceptable and does not require repair if it is within the following limits:</p> <ul style="list-style-type: none"> - Individual surface less than 300 mm² - 3 separations per tab face. - Distance between two separations less than 50 mm. <p>NOTE: <i>The blade has two tabs strips with three tabs each. Each tab is numbered from 1 to 6, from the blade tip to the blade root. On blades which can be replaced individually, 3160S-11-40.000 and 50.000, only tab number 6 can be adjusted by the operators and is left in the neutral position by the factory test bench. The other blade types are in sets, all 6 tabs are adjusted in the factory.</i></p> <p>(2) <u>Crack detection on tabs</u> (Figure 9)</p> <p>Effective for blades: 3160S 11 30 000 / 40 000 / 50 000</p> <p>Only cracks located in the prolongation of the slots between tabs are acceptable and require the installation of additional rivets.</p>
