SERVICE BULLETIN

MANDATORY No. 05.92

SUBJECT: TIME LIMITS
 Main Rotor Blade Root Skin and Reinforcement Strip Bonding Check

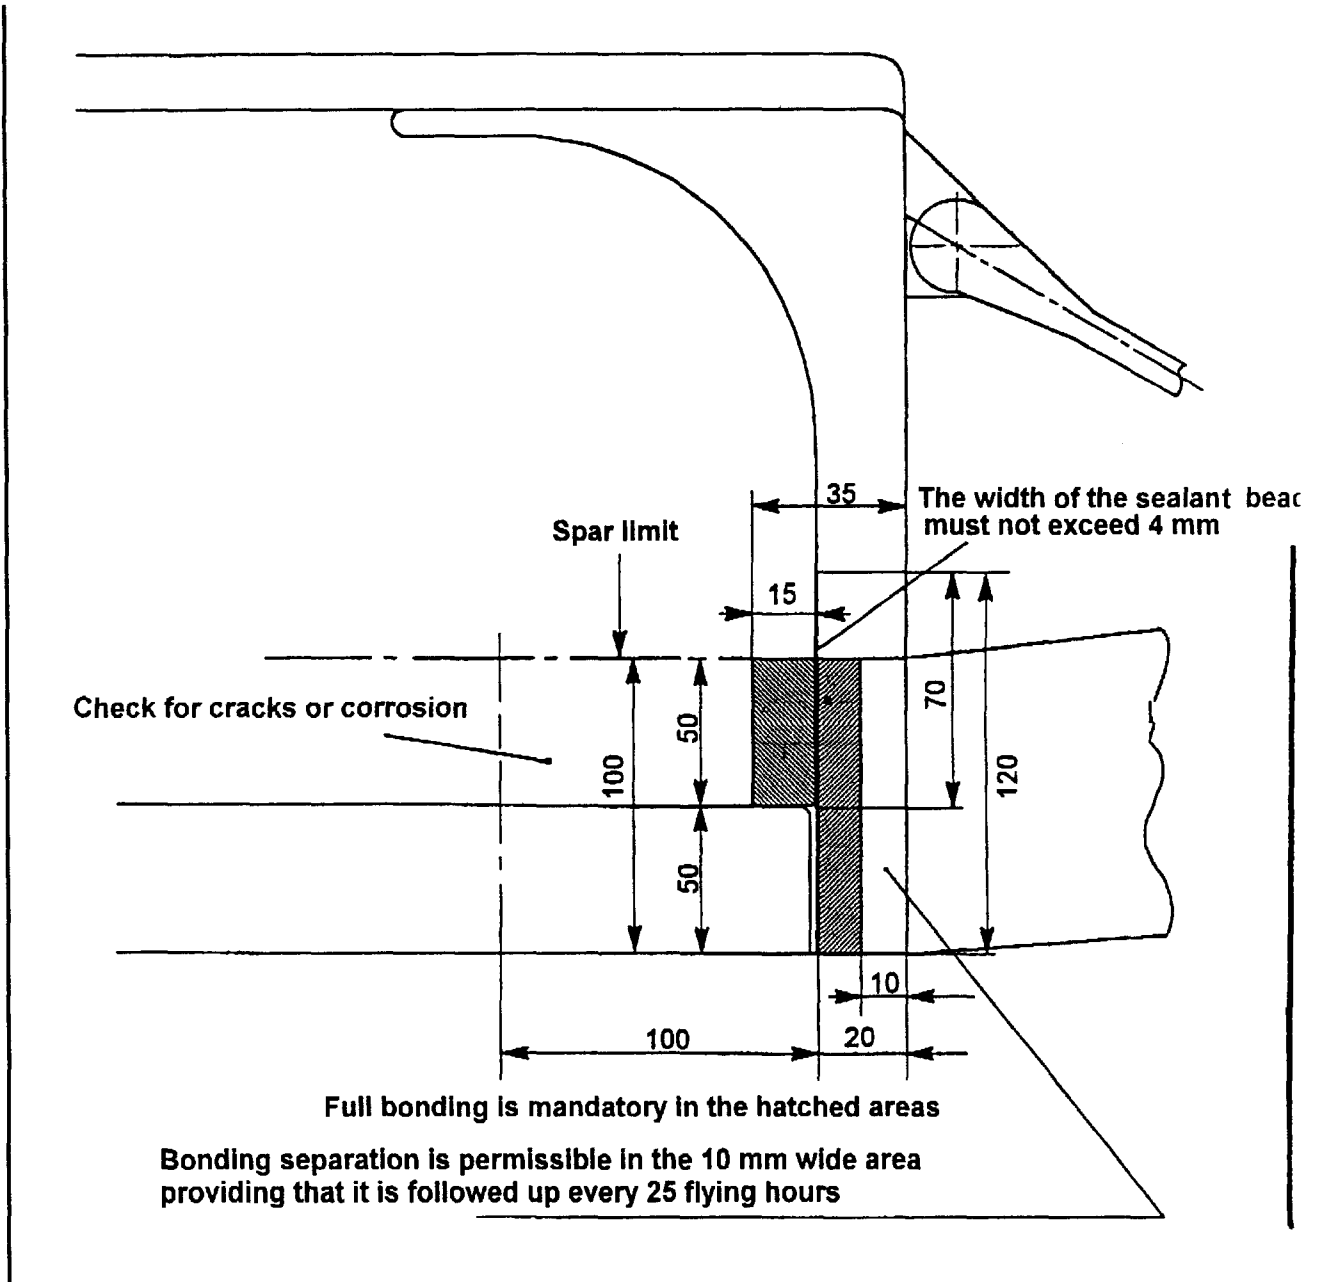
- Hatched area of skin on spar, 15 x 50 mm, aft of the stainless steel protection (upper surface and lower surface) see FIGURE 1

- Reinforcement strip area (upper surface and lower surface) (see FIGURE 1) R

- Check that there is no bonding separation in the reinforcement strip area (100 x 20 mm), using tapping method. R

- Bonding separation in the non-hatched area (10 mm) is permissible and must be checked using tapping method every 25 flying hours in order to monitor possible propagation. As soon as a bonding separation reaches the hatched area, the blade must be removed. R
R
R

- Check that there is no bonding separation in this area, using tapping method.
- If any bonding separation is detected in this area, the blade must be withdrawn from service.

- If any bonding separation is detected in the hatched area, the blade must be withdrawn from service. R
