SERVICE BULLETIN

RECOMMENDED No. 05.96

SUBJECT : TIME LIMITS / MAINTENANCE CHECKS
 Modification and Monitoring of the Tightening Torque of the Splined Bush Attachment Bolts on the Main Rotor Hub.

Corresponds to MOD 072323

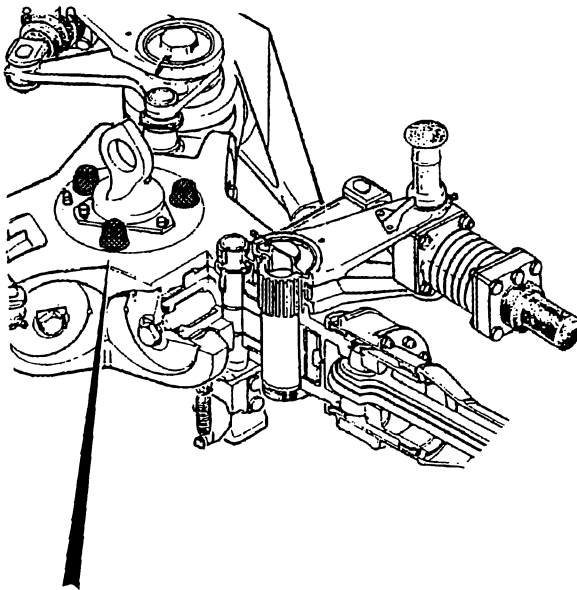
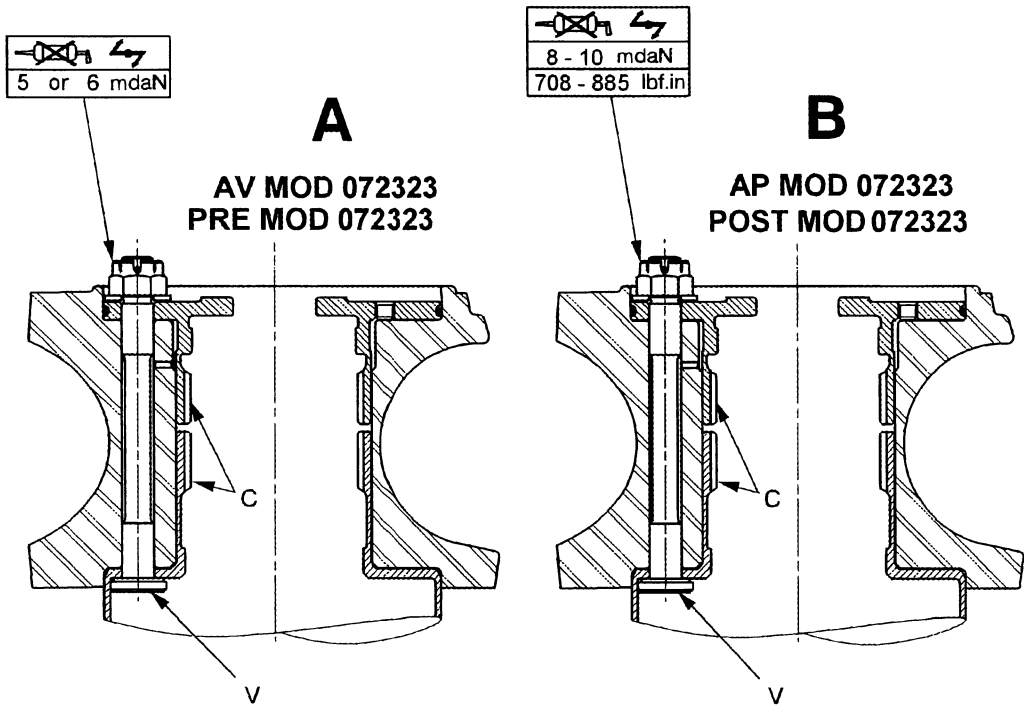
FIGURE 1

To improve the security of the 3 attachment bolts of the main rotor head splined bushes by increasing the tightening torque.
 EUROCOPTER recommends compliance with this Service Bulletin.

1. Increase in the tightening torque of the 3 bolts (V) which secure splined bushes (C)
(as per FIGURE 1, View A), (corresponds to MOD 072323).

- Remove the MRH as per work card 57.20.401 or 57.2.401.
- Remove bolts (V) (remove and check the bolts one by one).
- Check for possible cracks as per (MTC 20.02.09.101 or 20.02.09.102), using dye penetrant inspection or magna flux inspection, especially in the bolt head-to-bolt shaft connection area.

NOTE : Any bolt affected by a crack is to be scrapped and replaced with a new bolt, see paragraph 3.B.

- Fit bolts (V) (checked or new) which secure the splined bushes.
- Apply new dry tightening torque of 8 to 10 m.daN (as per FIGURE 1, View B).
- Install the MRH as per work card 57.20.401 or 57.2.401.

2. Readjustment of the tightening torque of the 3 bolts (V) which secure splined bushes (C)
(as per FIGURE 1, View B).

Adjust the dry tightening torque to 8 to 10 m.daN as per MTC 20.02.05.404, paragraph 1.2.2.
