SERVICE BULLETIN

MANDATORY No. 05.98

SUBJECT: TIME LIMITS / MAINTENANCE CHECKS
 Check of the Main Rotor Blade Root for Cracks.

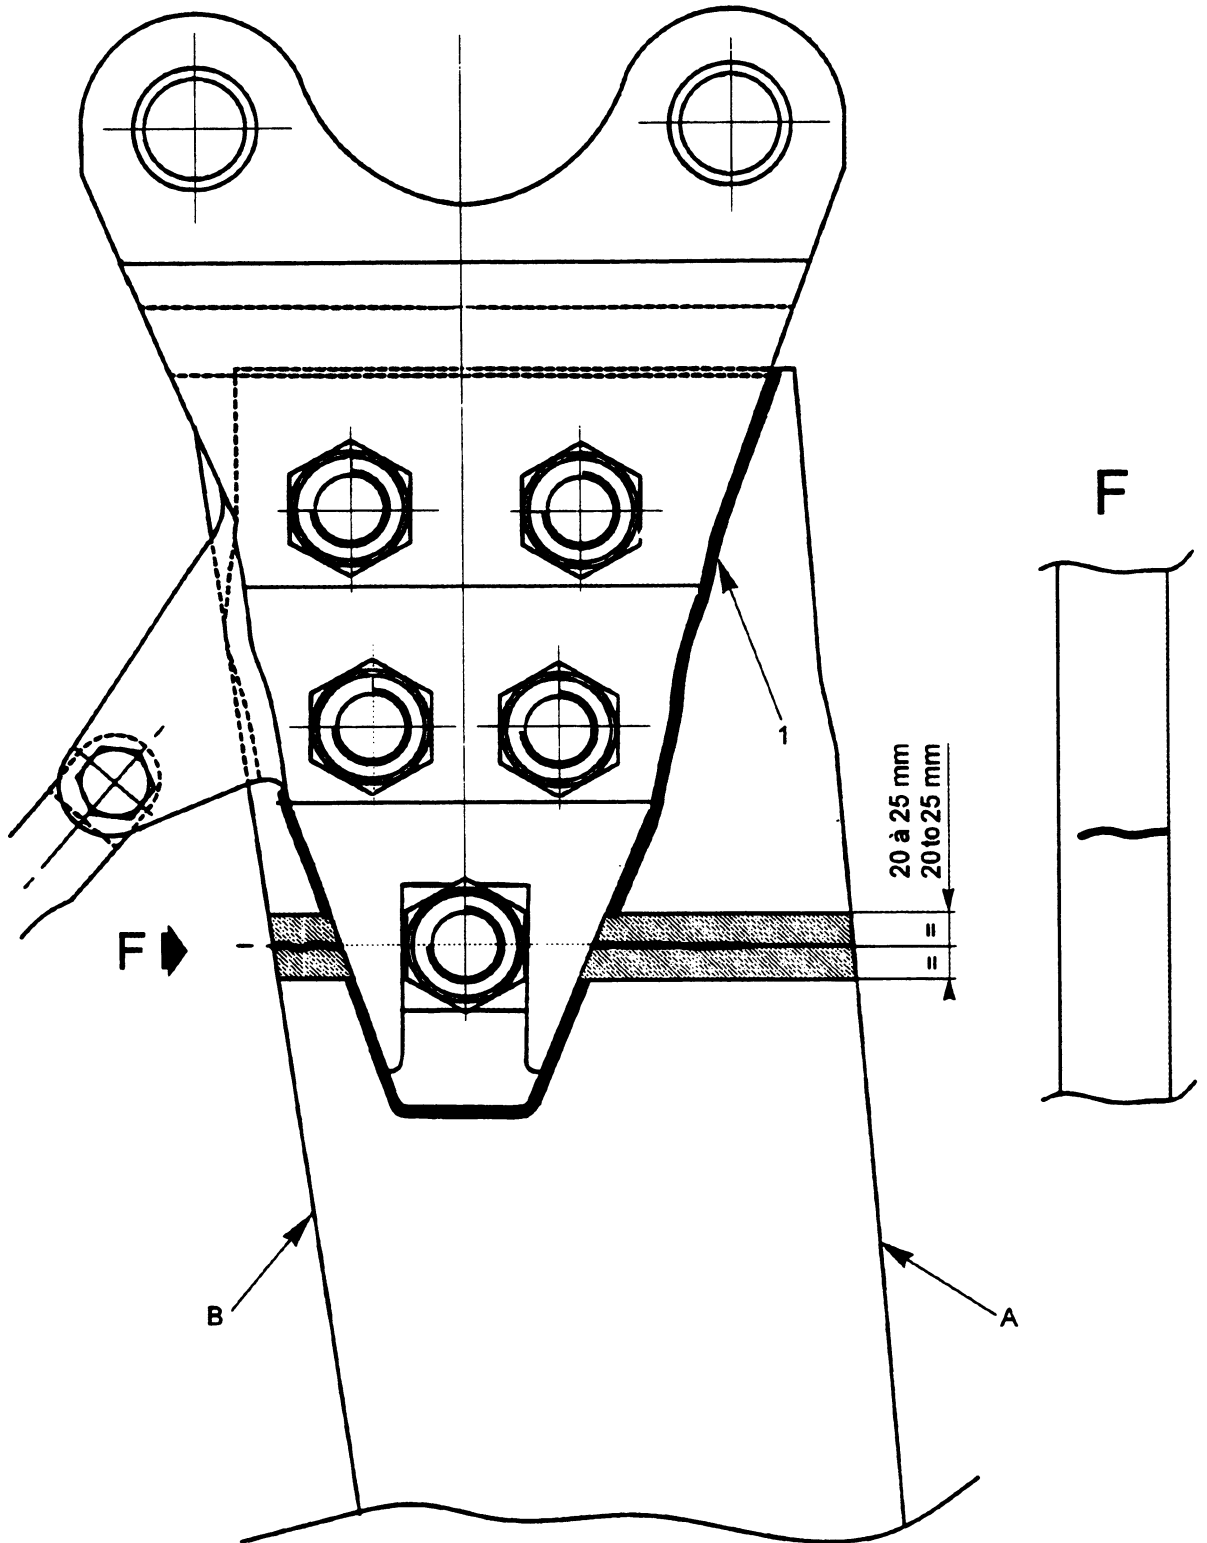
FIGURE 1

Further to the distribution of Service Telex No. 01.65 dated April 9, 1998 and after analyzing the results of the investigations carried on a LAMA helicopter main rotor blade (on which the spar had failed at the first cuff-to-spar assembly bolt), we have:

2. Check of the spar at the first blade cuff attachment bolt, FIGURE 1.

- Visually check the hatched areas for cracks.
- If necessary, use a tangential light or a magnifying glass with approximately tenfold magnification.
- Start with the check on the lower surface of the hatched area of the blade, then in continuation of this area, check the flat on the trailing edge side (B), the blade upper surface, then the flat side of the leading edge.

- Perform a dye penetrant inspection without stripping the paint, as per Standard Practices Manual MTC 20.02.09.101, or do an EDDY current inspection using a FORSTER defectoscope AF 2830 or 2833 F generator equipped with a HOCKING 314P24 2 MHz sensor or equivalent.

CAUTION : THE BLADE MUST BE WITHDRAWN FROM SERVICE IMMEDIATELY IF A CRACK IS DETECTED.

- Comply with the instructions given in paragraph 2.2 of Service Bulletin No. 65.137 R1 if this has not already been done. This operation consists in applying a sealant bead (1) around the cuff on blades manufactured or repaired before August 1989.
