N° 55.07

SUBJECT: STABILIZERS

Improvement of the flexible mounting of the stabilizer spar tube.

SERVICE BULLETIN

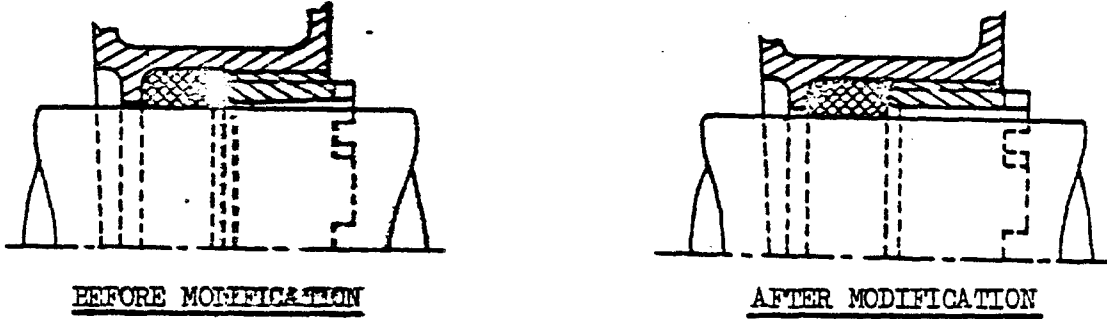
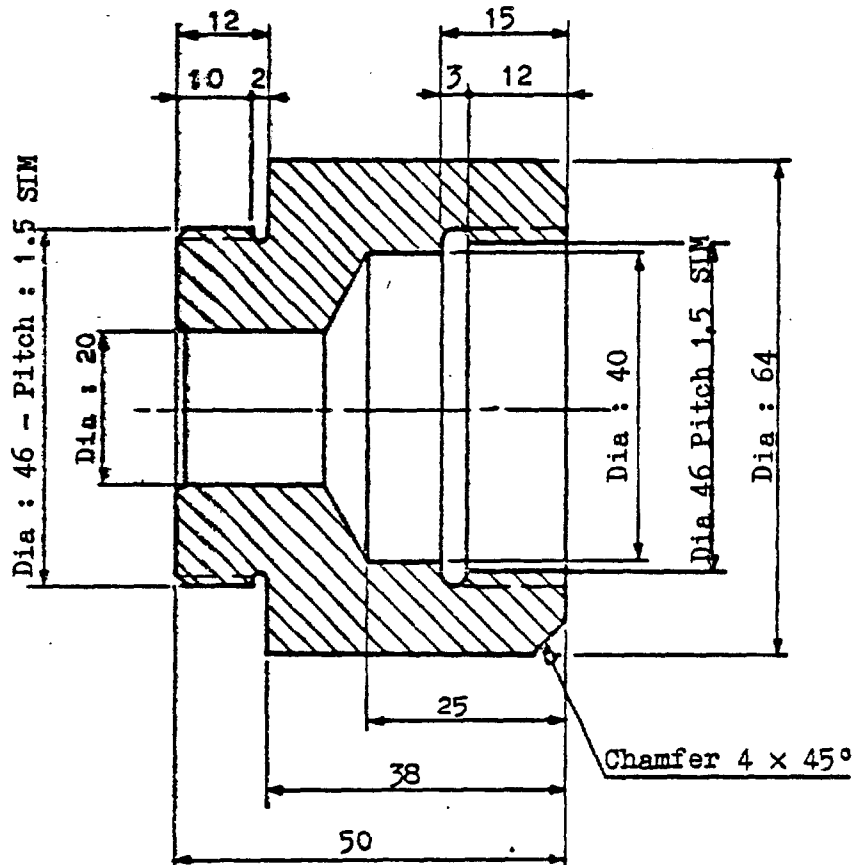
FIGURE 1

To avoid damage of the stabilizer spar tube and lengthen the inspection intervals which are extended from 200 to 400 hours.

- (1) In accordance with the dimensions of figure 1, manufacture a tool out of steel (C.20 for instance), in order to be able to machine stabilizer brackets 3160S.23.11.092 and 3160S.23.11.093 and castle nuts 3160S.23.11.099 on a lathe.
- (2) Remove the stabilizer, in accordance with the instructions given in the Maintenance Manual, chapter 55.
- (3) Remove brackets 3160S.23.11.092 and 3160S.23.11.093 from the tail boom.

- On a precision lathe, use the tool manufactured according to figure 1 to modify brackets 3160S.23.11.092 into 3160S.23.11.105 and brackets 3160S.23.11.093 into 3160S.23.11.106, by reworking the inside diameter :

dia. $37 \begin{smallmatrix} + 0.1 \\ 0 \end{smallmatrix}$ is machined to dia. $38 \begin{smallmatrix} + 0.1 \\ 0 \end{smallmatrix}$

radius 0.5 is machined to radius 1 mm.

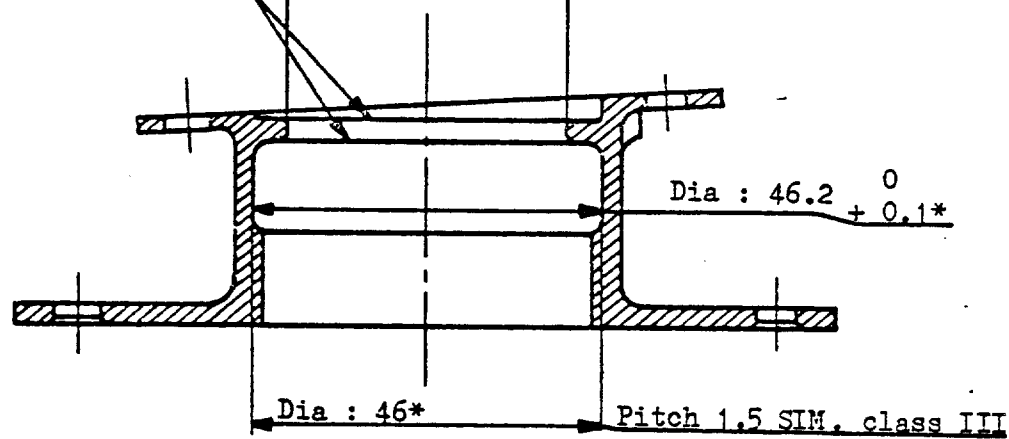
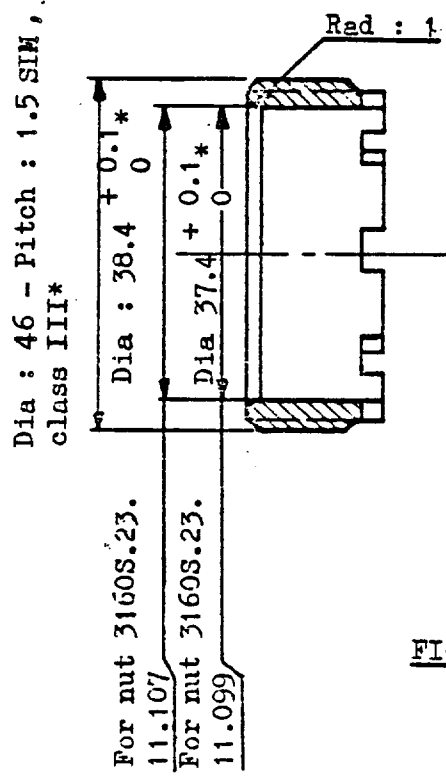
FIGURE 2

REMACHINING OF NUTS

- On a precision lathe, use the tool manufactured according to figure 1 to modify castle nuts 3160S.23.11.099 into 3160S.23.11.107, by remachining the inside diameter :

dia. $37.4 \begin{smallmatrix} 0 \\ + 0.1 \end{smallmatrix}$ is machined to $38.4 \begin{smallmatrix} 0 \\ + 0.1 \end{smallmatrix}$

and by making a 1 mm radius.
