## LETTRE SERVICE

### N° 221-65-76

**SUBJECT** : ALOUETTE all types and LAMA helicopters.  
**ROTORS** : Tail gear box.

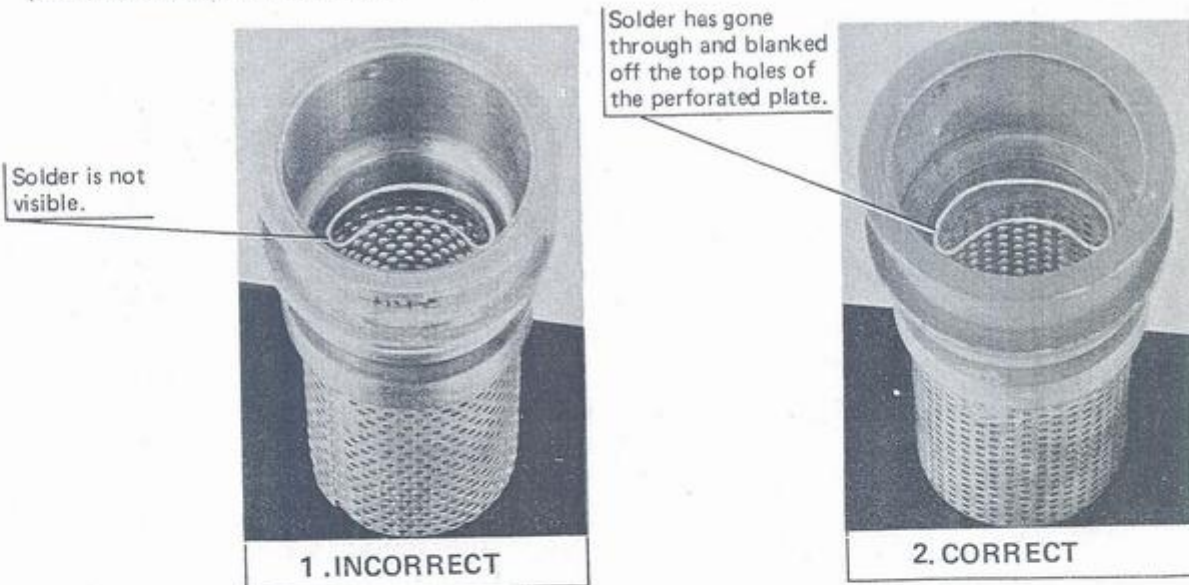
Several cases of faulty soldering of strainer P/N 3130S.66.20.300 fitted to tail gear box oil filler neck, have been reported to us recently.

On receipt of the present Service Letter, we would therefore recommend that you proceed to visual inspection of the strainers in service or supplied as spares to check for correct penetration of the solder into the perforated plate (see drawings 1 and 2 below) :

If solder penetration were found insufficient, clean the strainer and solder again (tin soldering).
