Lettre-Service

N.599- 6 5-84

SUBJECT : ALOUETTE III and LAMA
ROTOR : Bearing stack in the tail rotor blade pitch change hinge

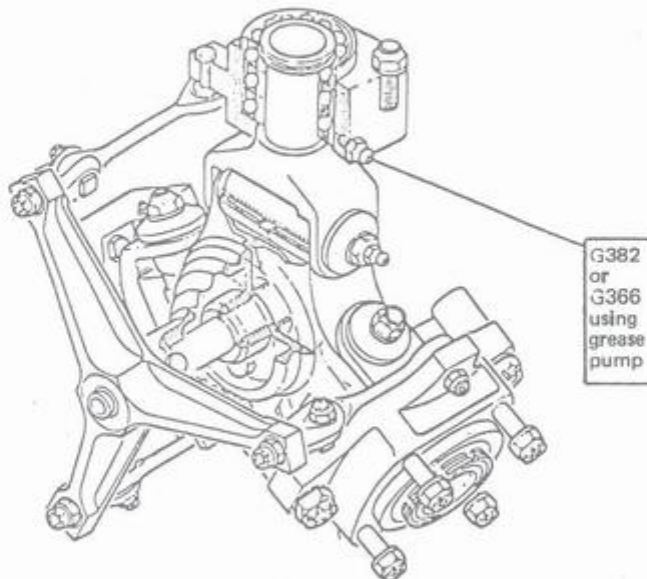
The tail rotor blade pitch change hinge bearings being sensitive to brinelling, we draw your attention on the importance of greasing to preserve the resistance of the hinge. The greasing procedure is described in Work Card 53.20.301.

The deterioration is caused by the low amplitude of the pitch change movements and the formation of fretting corrosion between the balls and the cups ; the degradation is also due to the aggressiveness of the environment (salty atmosphere, sand, etc ...) and to the vibrations caused by rotor unbalance.

For this reason, we think that the operating time of the bearings could be considerably extended by applying the recommendation of paragraph 3 (greasing and rotating the pitch change sleeve, 10 revolutions approx.) at rather short intervals depending on the severity of the operating conditions.

To perform this operation correctly, we remind you that it is necessary to mark the position of the two balance weights of each pitch change sleeve before removal in order to re-install the weights in the original position. Also check that the cup washers are correctly positioned when re-installing the pitch change links.

Greasing without removal is to be carried out after the last flight of the day as requested in the manuals.
